1. AGENCY USE ONLY (Leave Blank)	2. REPORT DATE	3. REPORT TYPE AND DATES COVERED	
	March 1996	Final Technical Report 010992 - 290296	
4. TITLE AND SUBTITLE  Damage and Failure Behavior of SiC SCS-6/Timetal 21S Metal Matrix Composite			5. FUNDING NUMBERS  FQ8671-9201544 2302/BS  <i>92-C-0063</i>

6. AUTHOR(S)  D. A. Shockley, S. W. Kirkpatrick, C. G. Schmidt, and T. Kobayashi			
7. PERFORMING ORGANIZATION NAME(S) AND ADDRESS(ES)  SRI International 333 Ravenswood Avenue Menlo Park, CA 94025-3493		8. PERFORMING ORGANIZATION  AFOSR-TR-96  <i>0250</i>

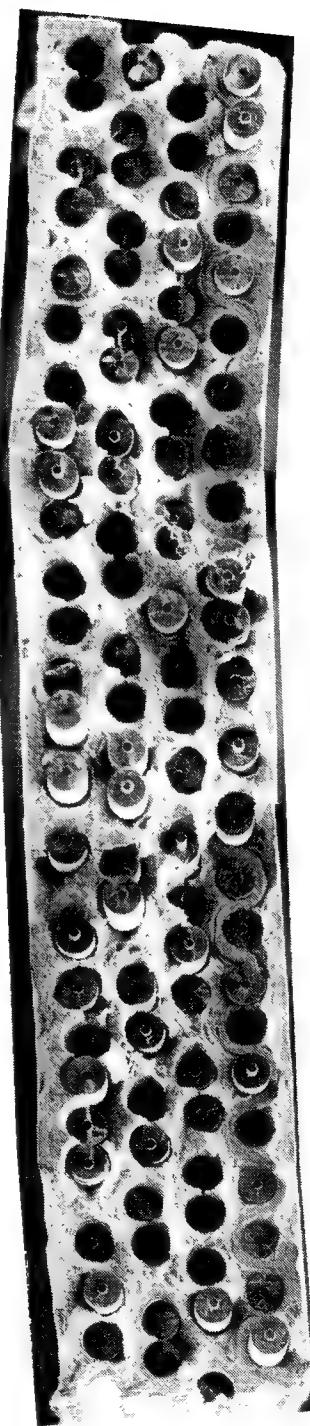
Figures 2.1 and 2.2 show scanning electron microscope (SEM) micrographs of fracture surfaces from  $[0]_4$  tensile specimens tested at 23° and 815°C, respectively. The fracture surface of the matrix component of the specimen tested at 23°C (Figure 2.2) exhibits the features of a material that failed in a ductile manner; however, in one of the composite plies, remnants of a molybdenum woof fiber is clearly evident (see Figure 2.1e). Evidence of the fiber appears on both sides of the fracture surface. An X-ray energy dispersive spectrometer (EDS) analysis of the woof fiber indicated that its composition is high in molybdenum (see Table 2.2). The measured compositions of the matrix and the fiber are consistent with the nominal compositions of Timetal 21-S and SiC, respectively.

Figure 2.1. SEM micrographs of the fracture surfaces from the 23°C tensile test of Specimen 91-254.

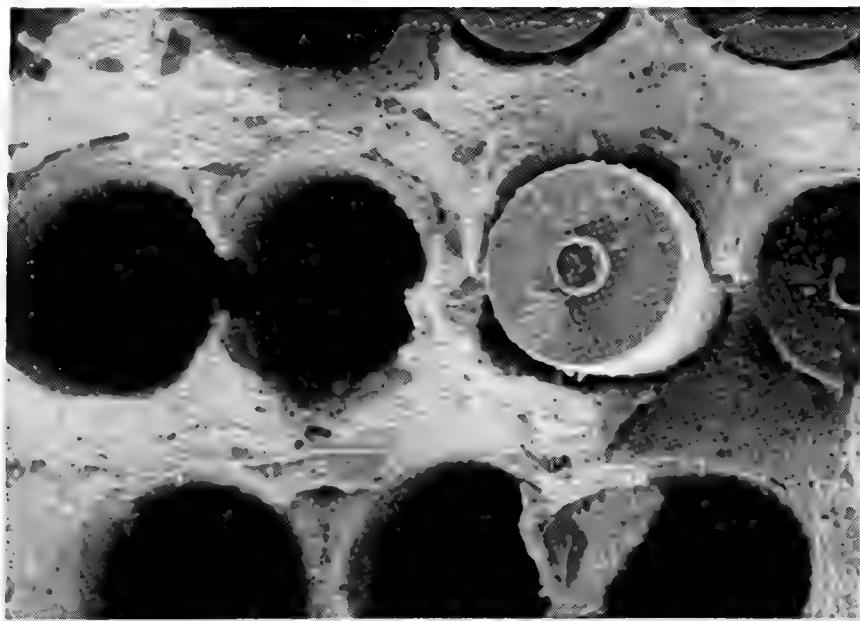
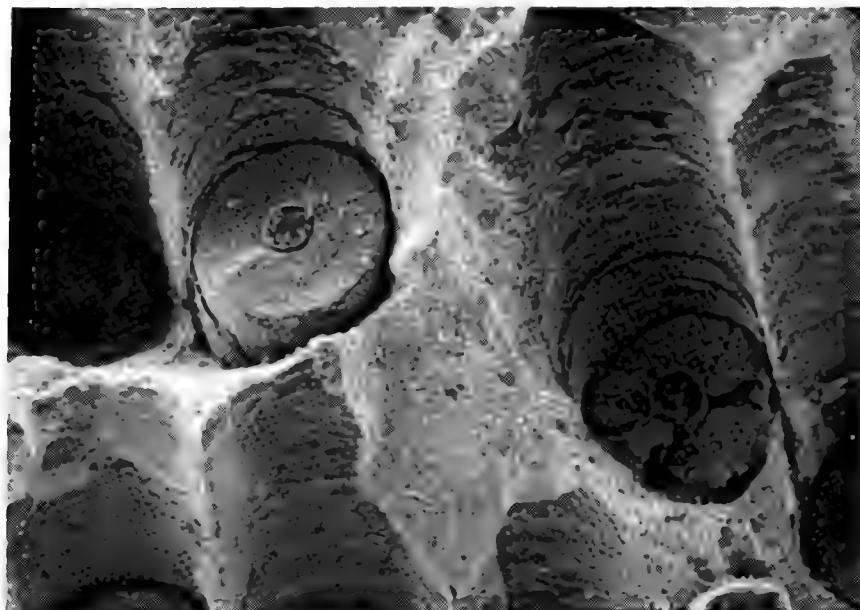
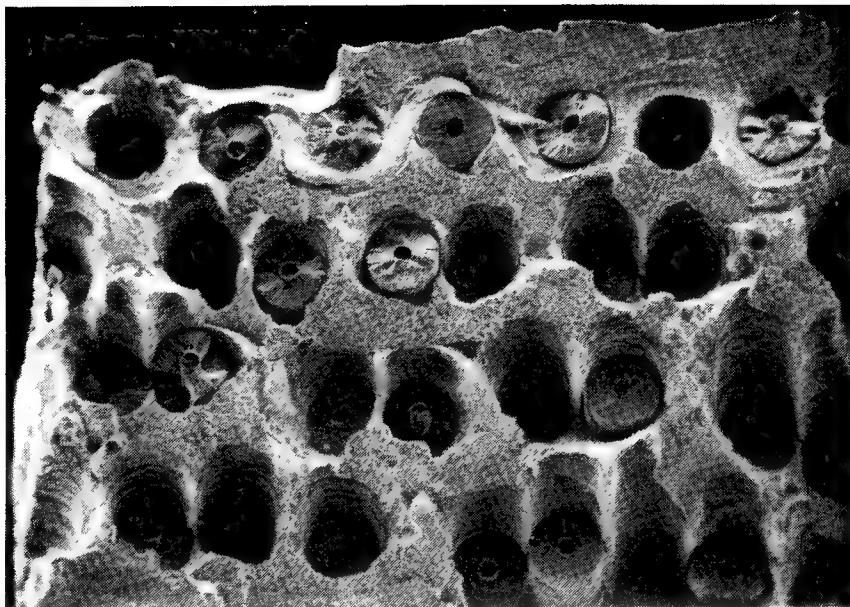
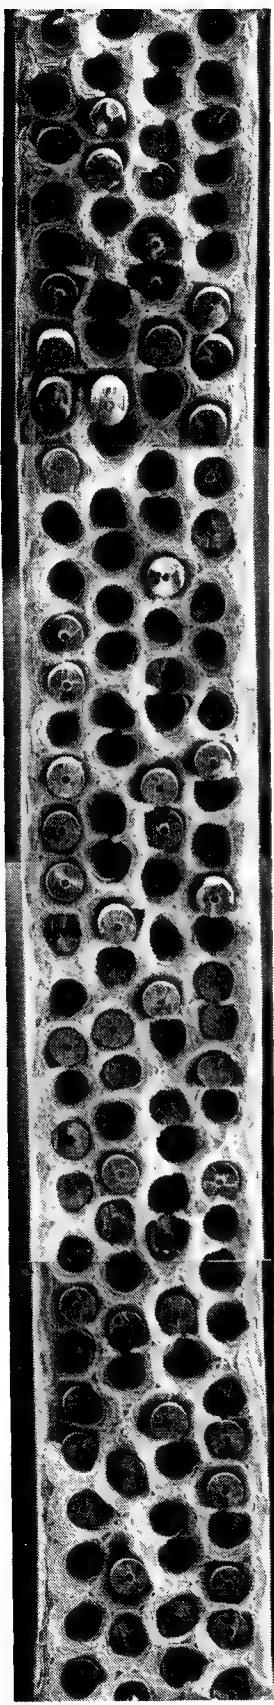
(a) Side A

(b) Side B

(c) Orthogonal high magnification view of area on Side A

(d) Angled high magnification view of area on Side A

(e) High magnification view showing molybdenum fiber

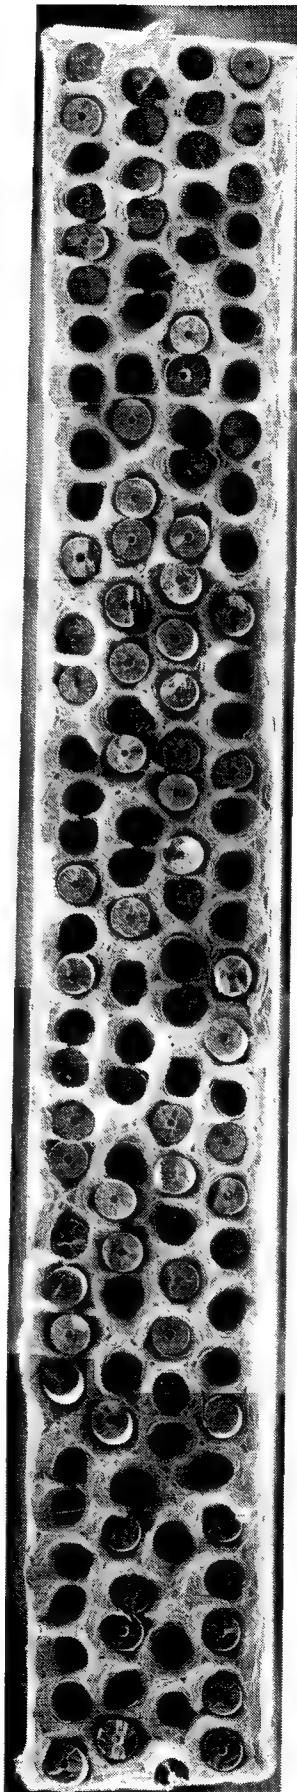
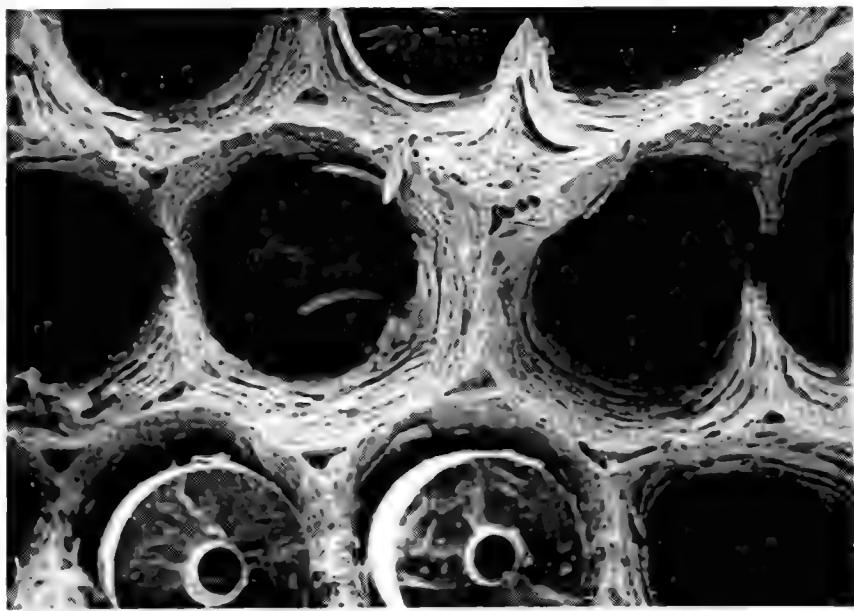
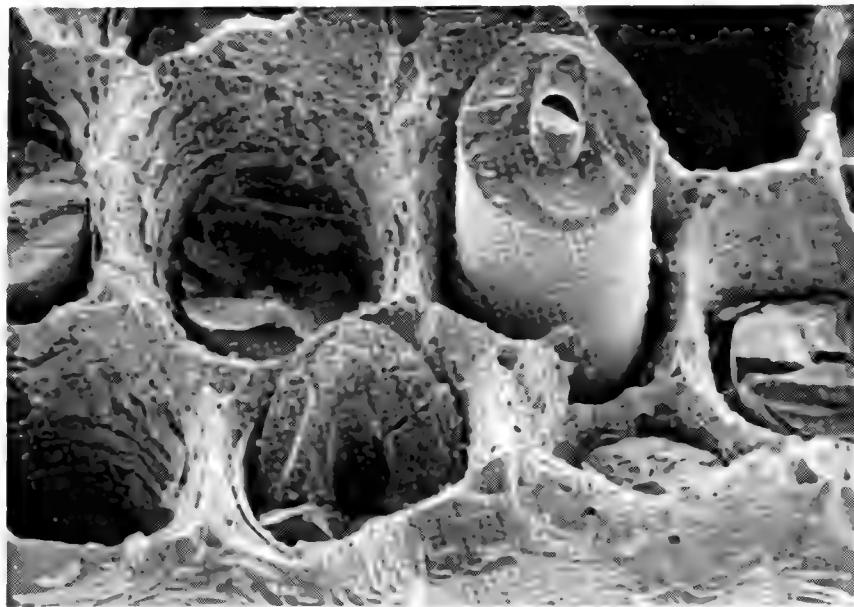
Figure 2.2. SEM micrographs of the fracture surfaces resulting from the 815°C tensile test of Specimen 91-247.

The appearance of the matrix material on the fracture surface of the  $[0]_4$  tensile specimen tested at 815°C shows greater ductility than the fracture surfaces from the 23°C test. To better compare the differences between the specimens tested at these two temperatures, a scanning laser microscope was used to topographically characterize representative regions of the fracture surfaces from tensile specimens tested at 23° and 815°C, as shown in Figure 2.3. Figure 2.4 compares the fracture surface profile of the matrix material between two fibers in 23° and 815°C test specimens. The fracture surfaces of the matrix from the 23°C test are relatively flat and at an angle that

(c) Orthogonal high magnification view of area on Side A

(d) Angled high magnification view of area on Side A

suggests a ductile shear dominated failure process. The fracture surface of the matrix material in the 815°C test indicates a ductile necking type of failure.

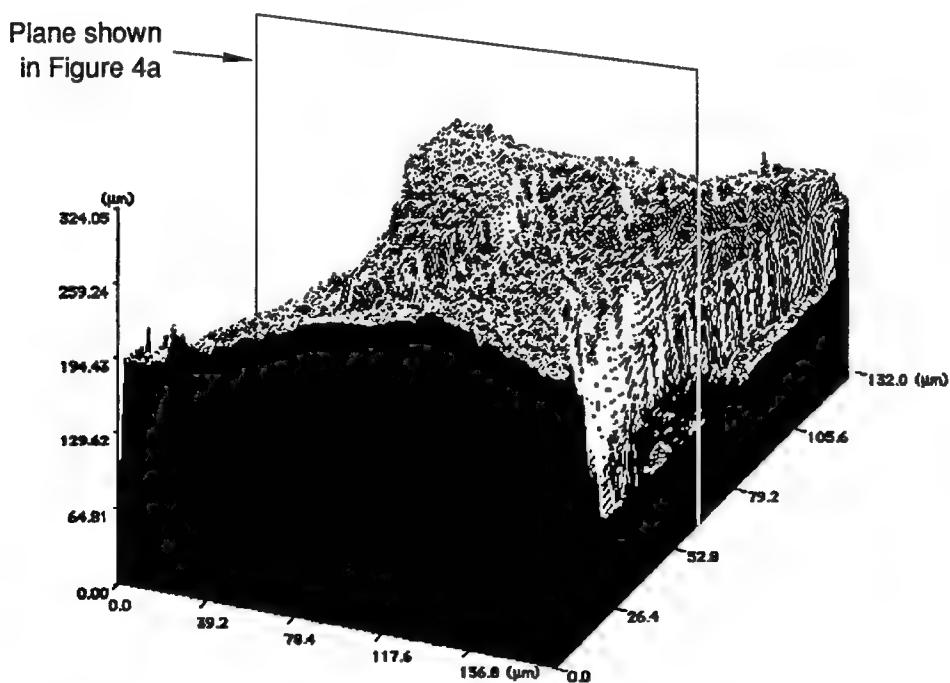
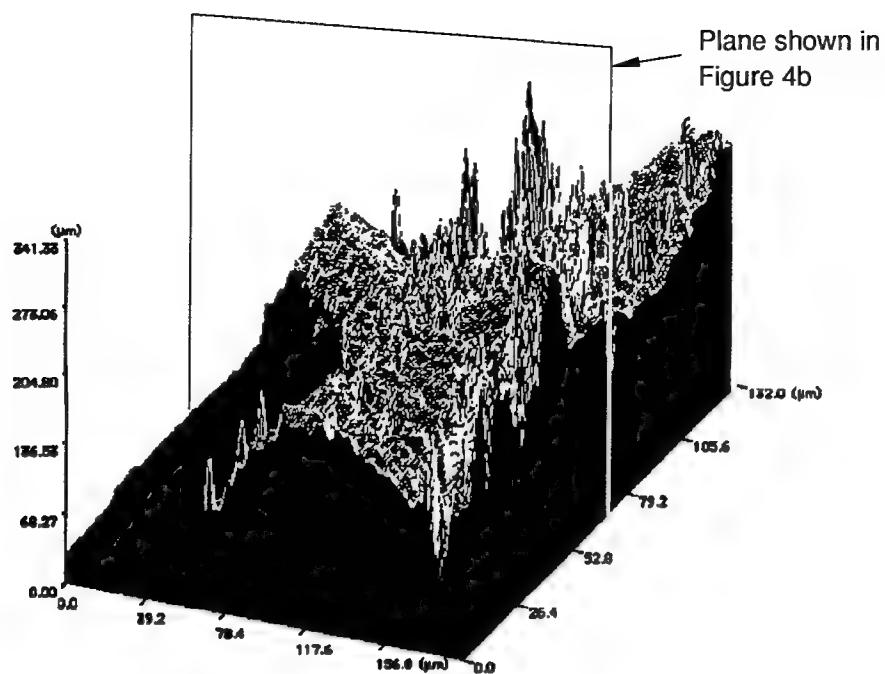
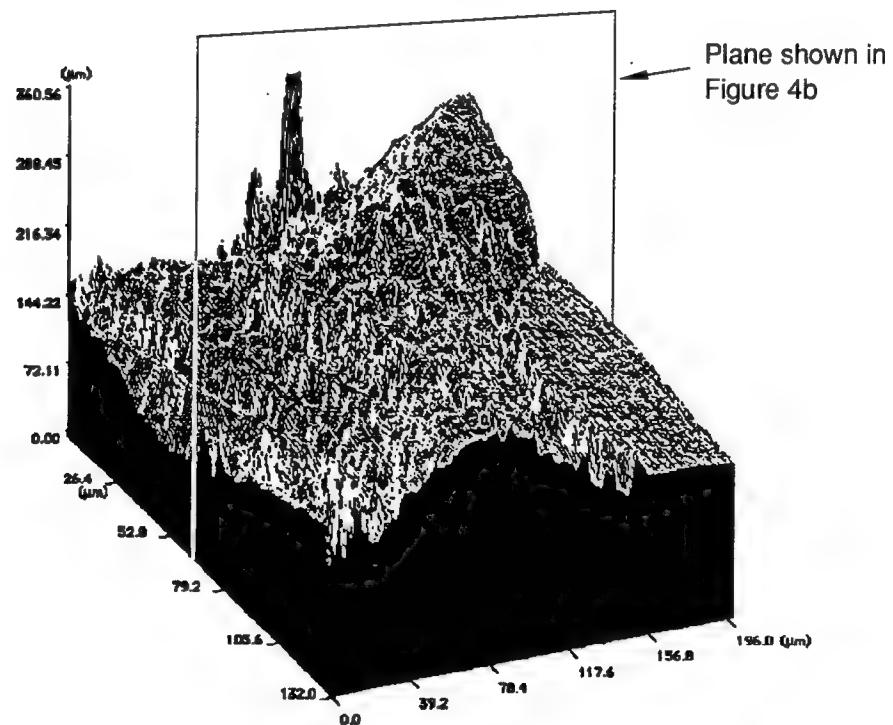
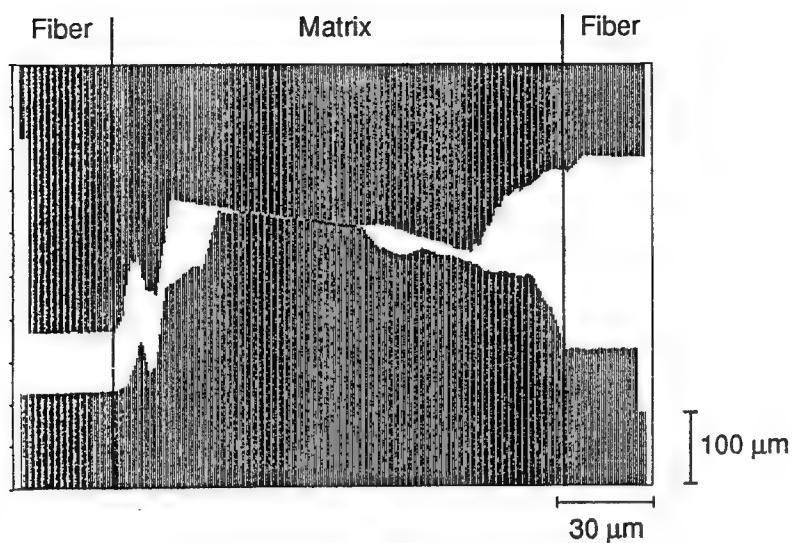
Figure 2.3. Fracture surface profiles measured with a scanning laser microscope.

(a) Top fracture surface profile in Figure 4a (23°C test; Specimen 91-254)

(b) Bottom fracture surface profile in Figure 4a (23°C test; Specimen 91-254)

(c) Top fracture profile in Figure 4b (815°C test; Specimen 91-247)

(d) Bottom fracture surface profile in Figure 4b (815°C test; Specimen 91-247)

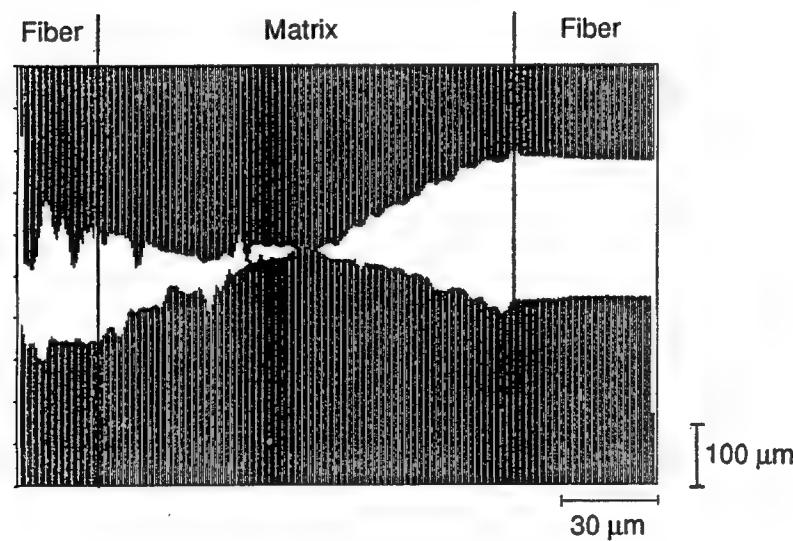
Figure 2.4. Conjugate fracture surface profile from [0]4 tensile test specimens.

(a) 23°C Test; Specimen 91-2154

(b) 815°C Test; Specimen 91-247

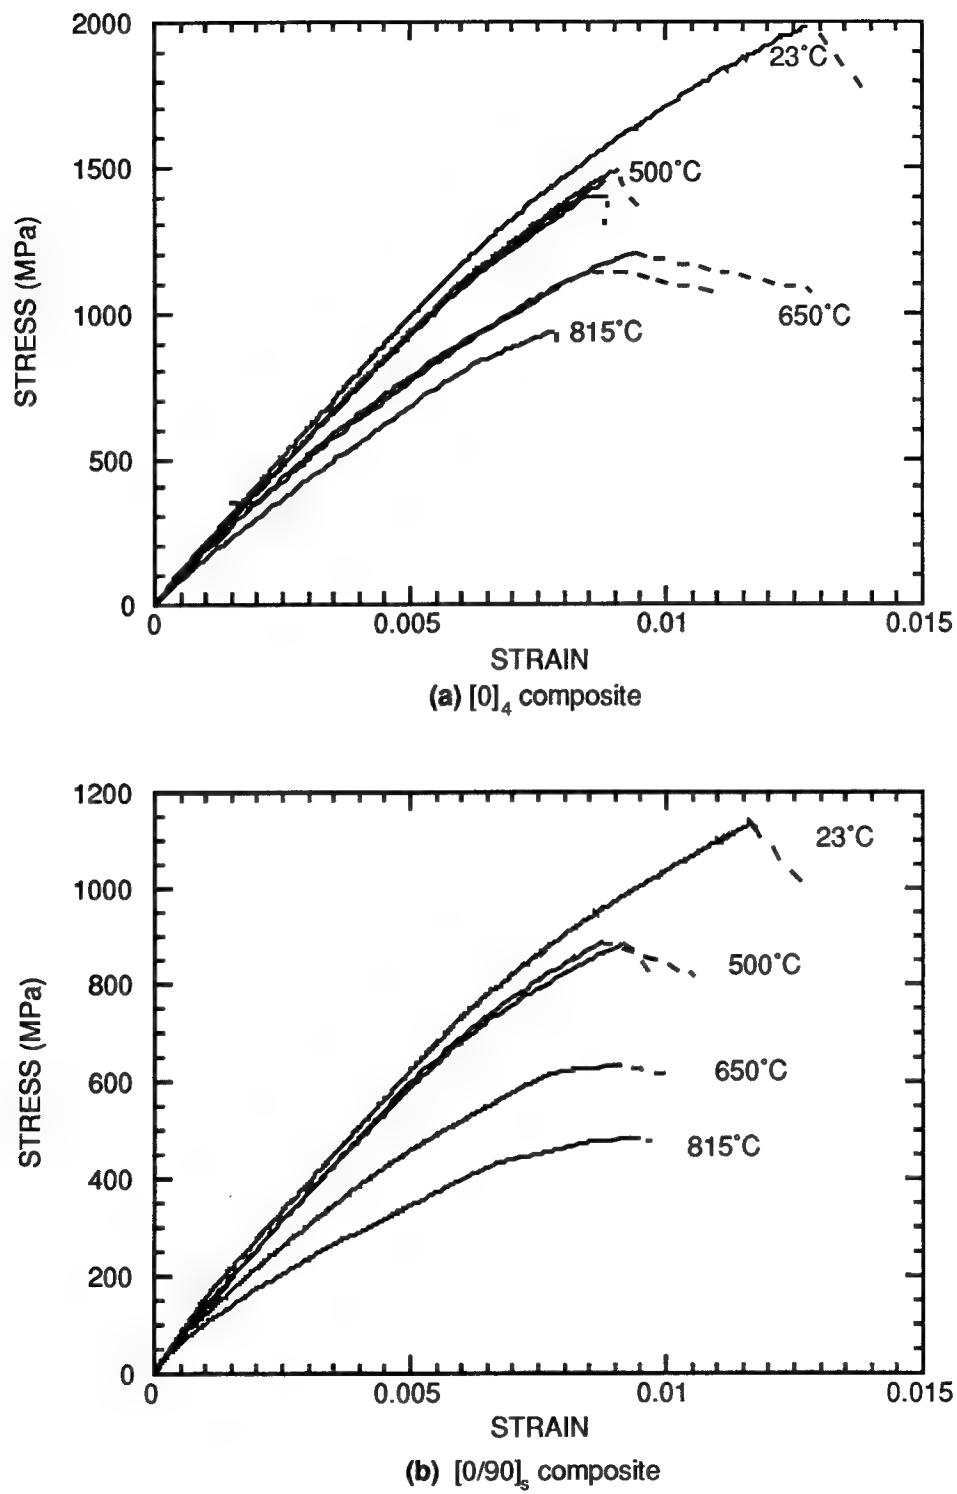
Figure 2.5 compares the stress-strain responses of several [0]4 and [0/90]s tensile test specimens that were examined in this investigation. To estimate the contribution of the matrix and the fibers to the stress-strain behavior of the tests on the [0]4 composite shown in Figure 2.5a, an isostrain rule-of-mixtures (ROM) approach was employed, with no bonding between the fibers and the matrix. This approach is consistent with that used by Larsen and Nicholas<sup>1</sup> and by Neu and Nicholas<sup>2</sup> in their analysis of thermomechanical fatigue of SCS6/Timetal 21-S composites. We assumed that no damage (i.e., cracking) occurs to the matrix during loading until the maximum load is reached. The stress-strain behavior of the Timetal 21-S matrix material was determined from a version of the Bodner-Partom model developed by Neu.<sup>3</sup> Figure 2.6 shows calculations of the fraction of the load borne by the fibers in [0]4 composite tensile tests at various temperatures.

Figure 2.5. Stress-strain curves for SCS6/Timetel 21-S composite.

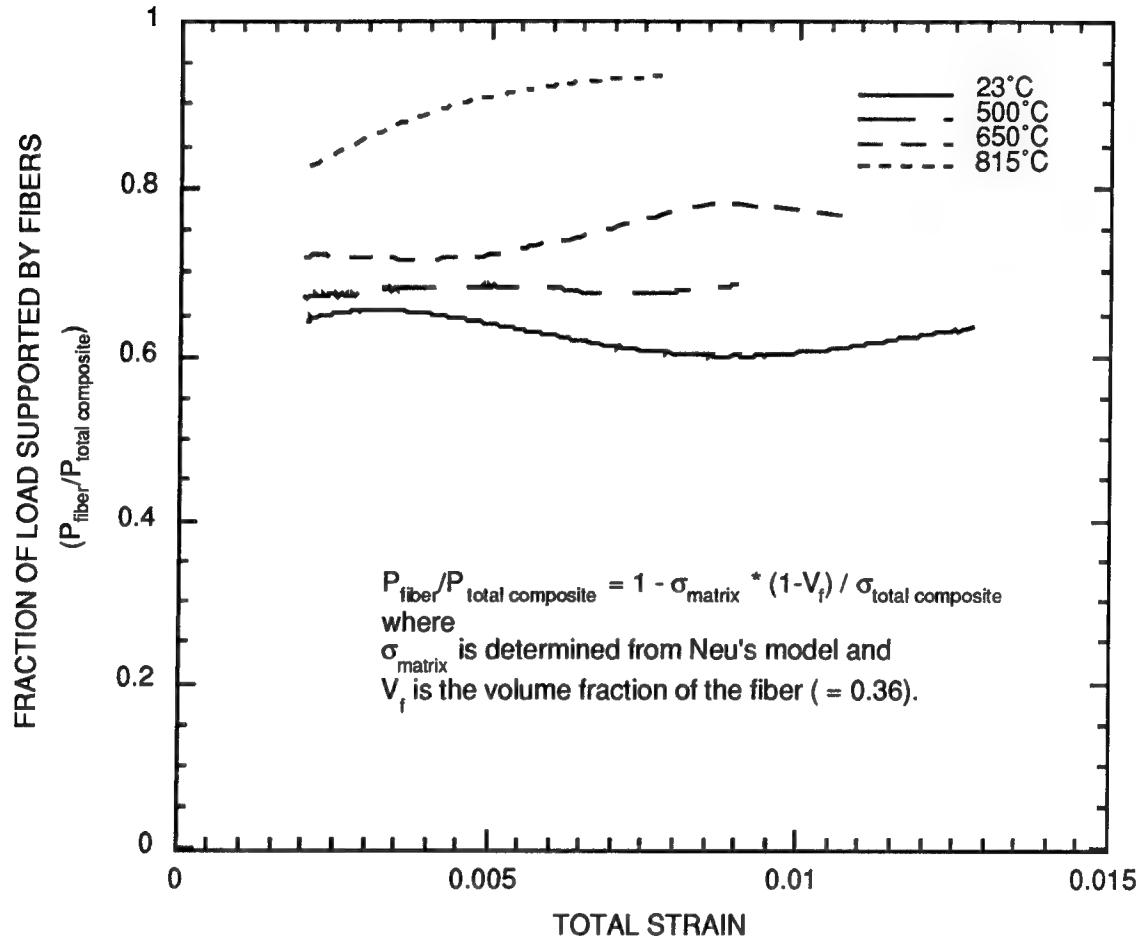
These ratios were determined by subtracting the matrix contribution obtained from Neu's model from the measured stress-strain behavior of the composite and dividing this difference by the measured stress-strain behavior of the composite. Figure 2.6 shows that the fibers bear a majority of the load in all cases (i.e., a little more than 60% of the load at 23°C and as much as 93% of the load at 815°C).

Figure 2.6. Fraction of the load supported by fibers in tensile tests on  $[0]_4$  SCS6/Timetal 21-S composite.

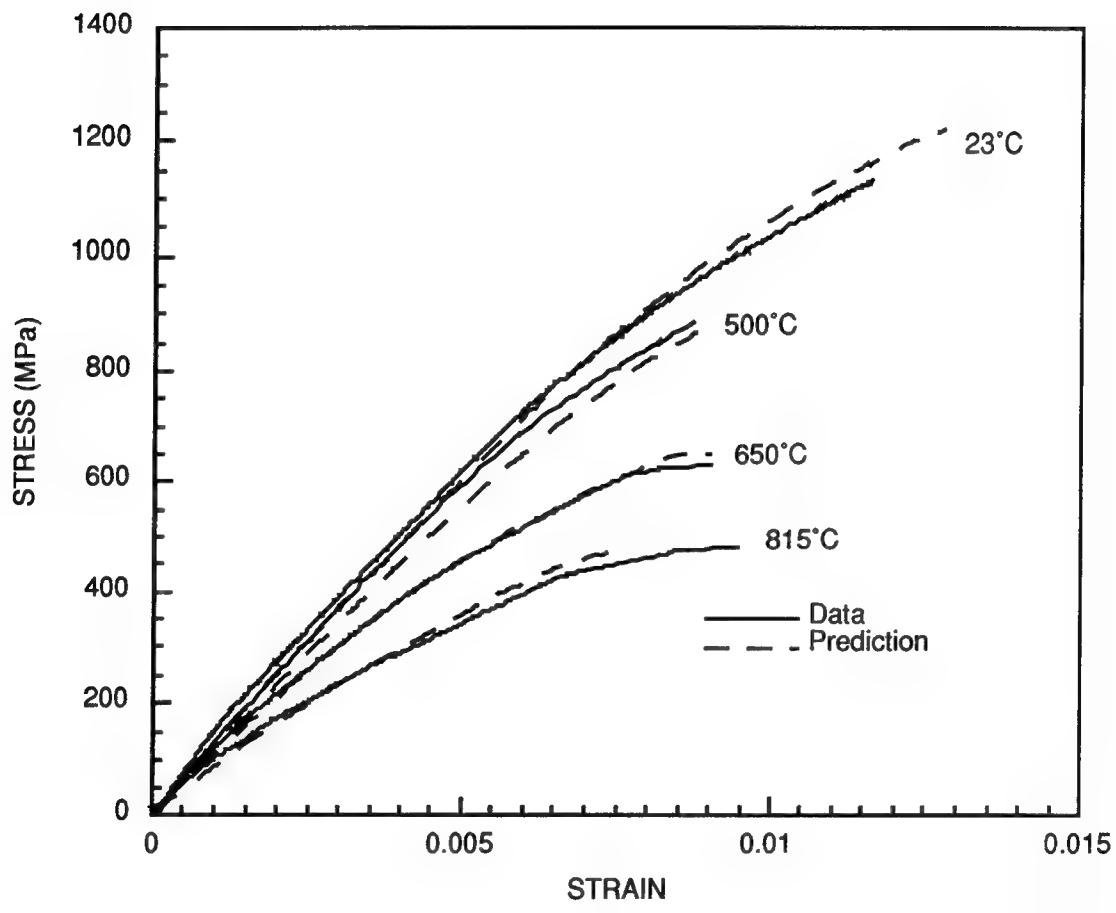
Figure 2.7 compares the predictions and the measured values of stress in the [0/90]<sub>s</sub> tensile tests up to the maximum stress. The comparison shows very good agreement.

Figure 2.7. Comparison of measured and predicted stress-strain behavior for  $[0/90]_s$  SCS6/Timetal 21-S composite based on  $[0]_4$  data and Neu's model for Timetal 21-S.

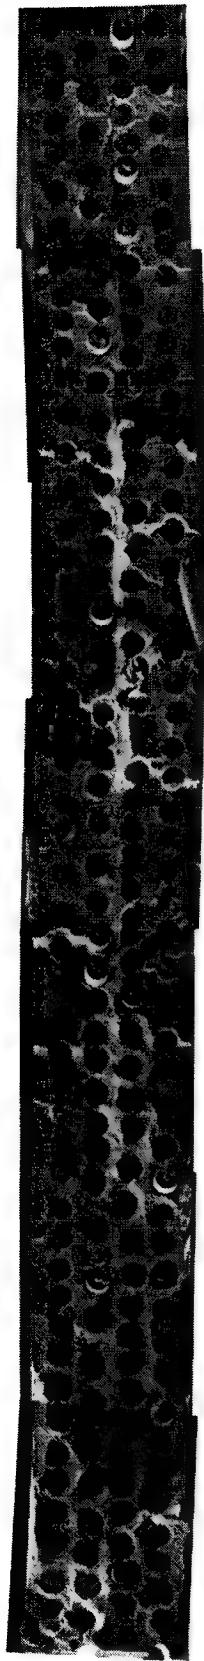
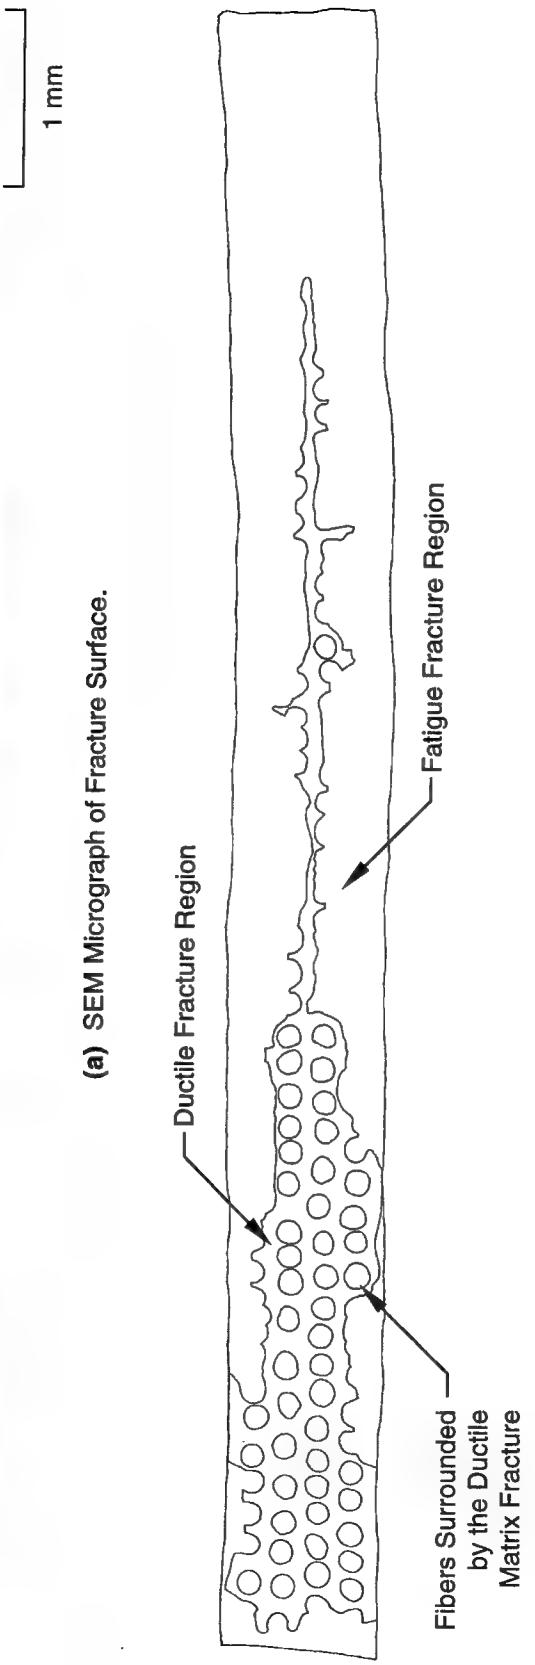
Figure 3.1. Fracture surface of thermomechanical test specimen.

Figure 3.1 shows a fracture surface of the thermomechanical test specimen. The right side of the fracture surface is dominated by a fatigue-induced, flat fracture surface that extends from the outer surface of the specimen and penetrates toward the center. Neu and Nicholas<sup>2</sup> described the

failure process exhibited by this specimen to be matrix-dominated, because failure initiates in the matrix at the outer surface of the specimen and, with the aid of the environment, propagates through the matrix of the composite. Propagation of the fatigue-induced cracks is incomplete, however, so that a region of ductile rupture is evident between the innermost rows of fibers. It is the ductile fracture regions that fail in the last loading cycle and, therefore, contribute to the residual strength of the composite after fatigue loading. On the left side of Figure 3.1, the region of fatigue-induced fracture features are small so that fracture is dominated by ductile fracture. Figure 3.1b is a map that delineates the ductile and fatigue-induced regions of the fracture surface.

As a first estimate, we considered all of the fibers that were surrounded by ductile matrix failure to be unbroken by the thermomechanical fatigue. Figure 3.1b shows the locations of the 48 fibers within the region of ductile matrix failure. Using a fiber strength of 3450 MPa reported by Ward, Herrmann, and Hillberry,<sup>10</sup> we estimate the load supported by the 48 unbroken fibers to be 260 kg.

The area of ductile failure depicted in Figure 3.1b was measured to be 2.28 mm<sup>2</sup>. Experimental measurements, reported by Neu,<sup>11</sup> of the tensile properties of similarly processed Timetal 21-S (i.e., so called "neat material") indicate that the maximum stress at 25°C and 500°C is 1150 MPa and 970 MPa, respectively. Interpolating to the temperature where the load was a maximum in the thermomechanical fatigue cycle (i.e., 150°C) indicates that the maximum stress for the matrix was 1050 MPa. This strength value corresponds to a load that is supported by the region of ductile matrix failure shown in Figure 3.1 to be 244 kg.

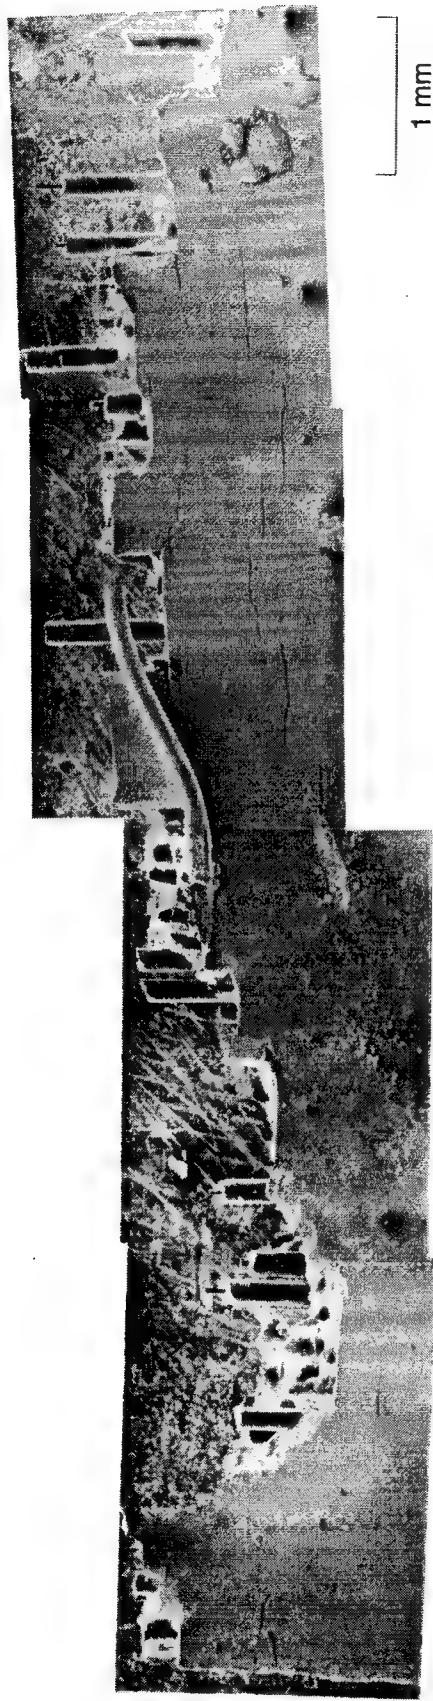
Figure 3.2. Side view of fracture surface.

As mentioned above, only those fibers that were completely surrounded by ductile matrix failure were assumed to contribute to the residual strength. Examination of Figure 3.1 revealed that 61 fibers are partially in contact with the ductile matrix failure region. If half of these fibers were unbroken (about 30), the estimated residual strength would be 793 kg, which is in good agreement with the maximum applied load (785 kg).

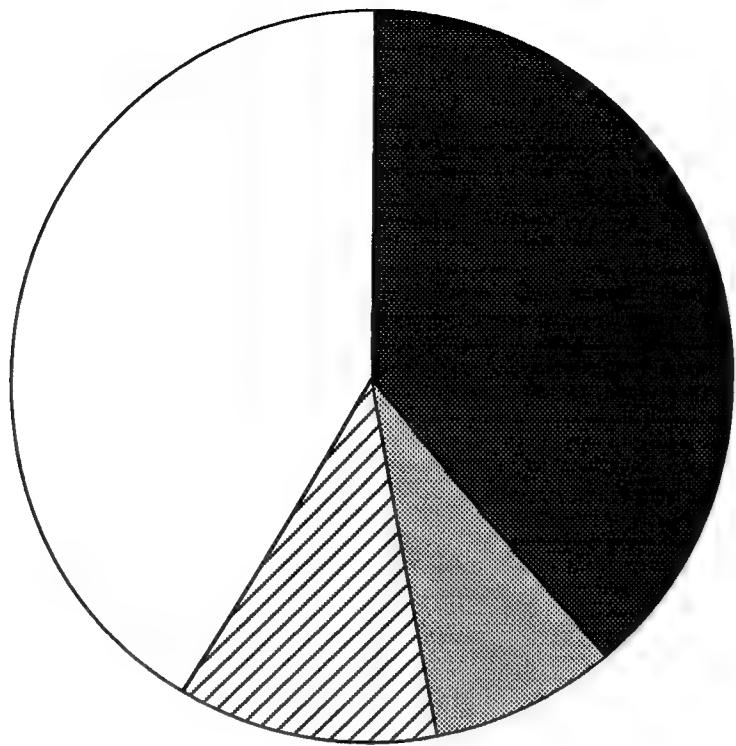
Total Calculated Load = 630 kg  
Maximum Applied Load = 785 kg

- 260 kg Load from Fibers in Ductile Fracture Region
- 244 kg Load from Ductile Matrix Fracture Region
- ▨ 52 kg Load from Shear Fracture Region
- / 74 kg Fiber/Matrix Friction Load

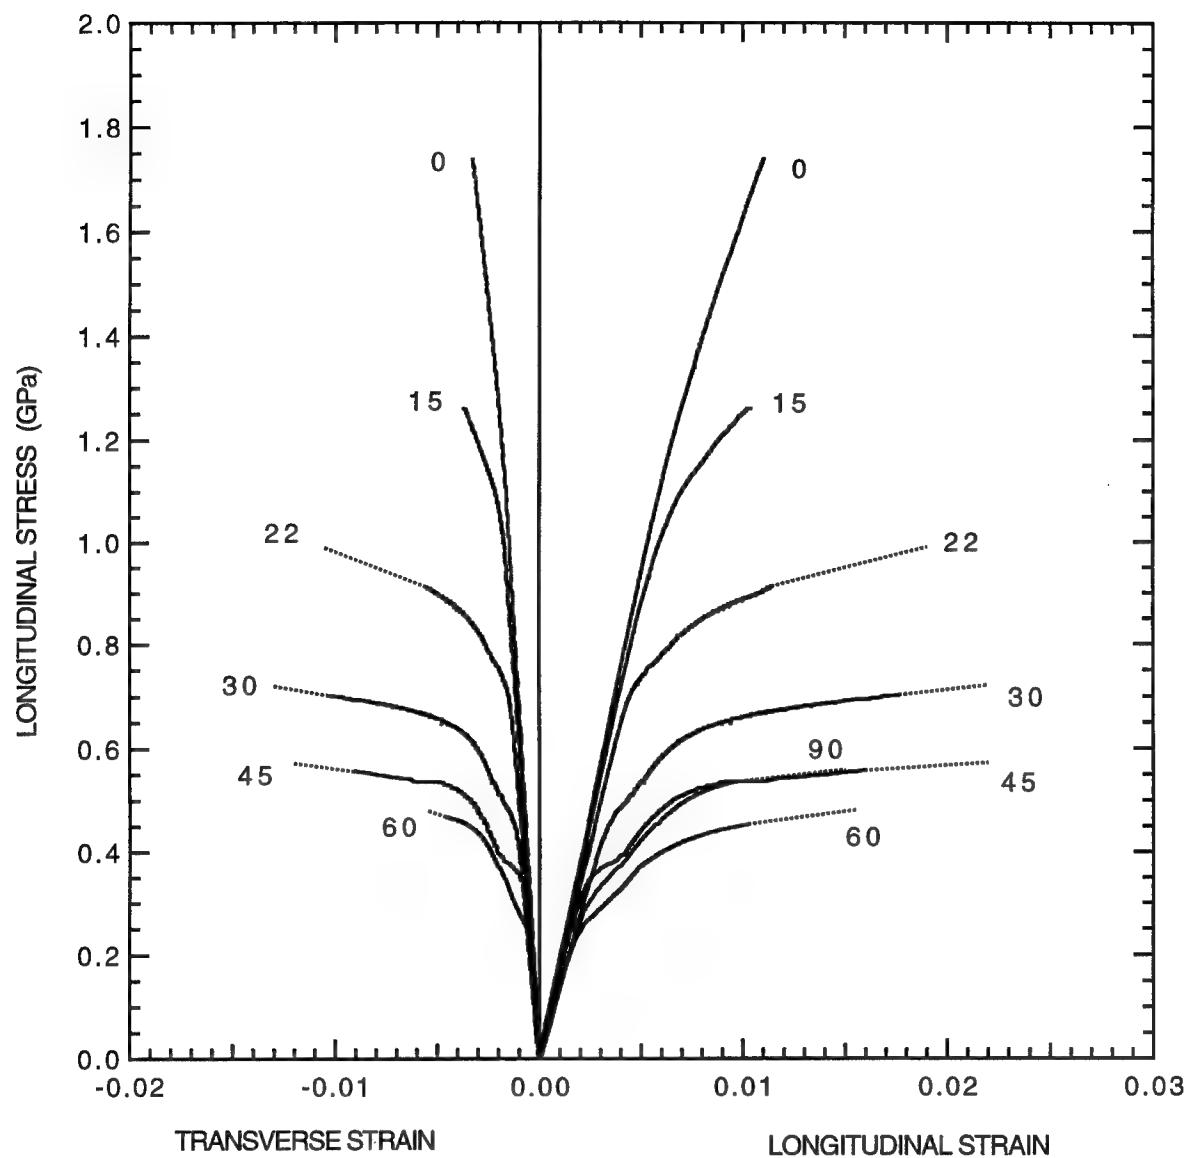
Figure 4.1 shows typical off-axis, stress-strain behaviors measured for the SCS-6/Timetal 21S. Extrapolation of the stress-strain curves to the ultimate failure point was required for some tests as a result of premature strain gage failures that occurred with the higher ductility. The extrapolated portions of the curves are indicated by the dotted lines in Figure 4.1. In all cases shown, the strain gages remained attached to within 8% of the ultimate failure stress. We have modified the strain gage application process to eliminate this problem in future tests. Inspection of the stress-strain curves shows that loading transverse to the fiber direction produces a clear three-stage response that results from the deformation mechanisms of initial elastic response, fiber-matrix debonding, and matrix plasticity, respectively.<sup>15</sup> The off-axis curves also show a lower strength for the 60° orientation than for the 90° orientation, illustrating the importance of shear stress on damage and strength.

Figure 4.1. Measured stress-strain behaviors for the SCS6/Timetal 21-S off-axis tensile tests.

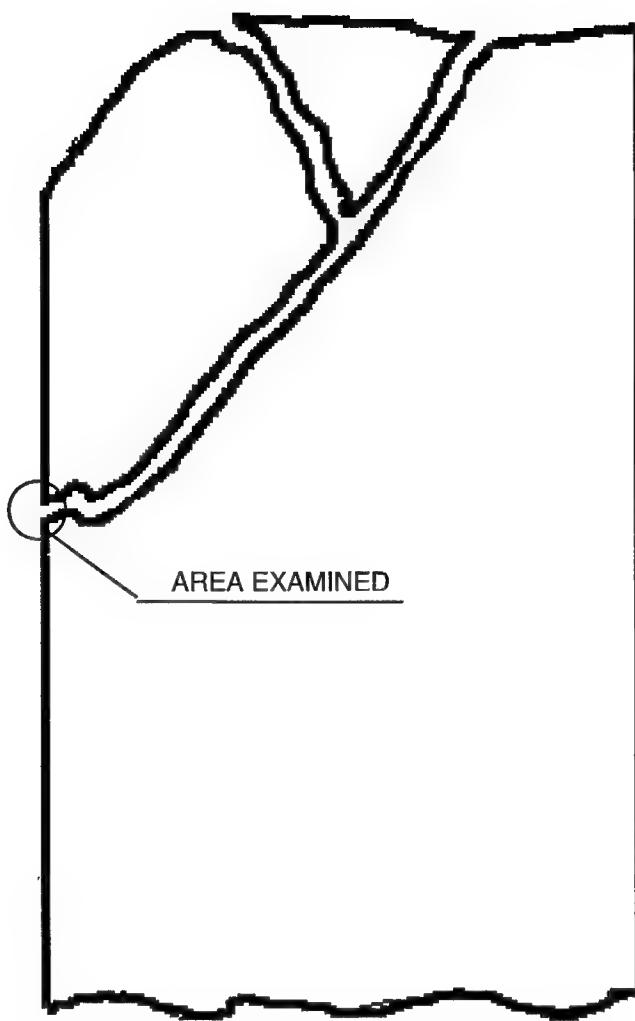
Figure A.1. Sketch showing fracture pattern and the location where FRASTA was applied.

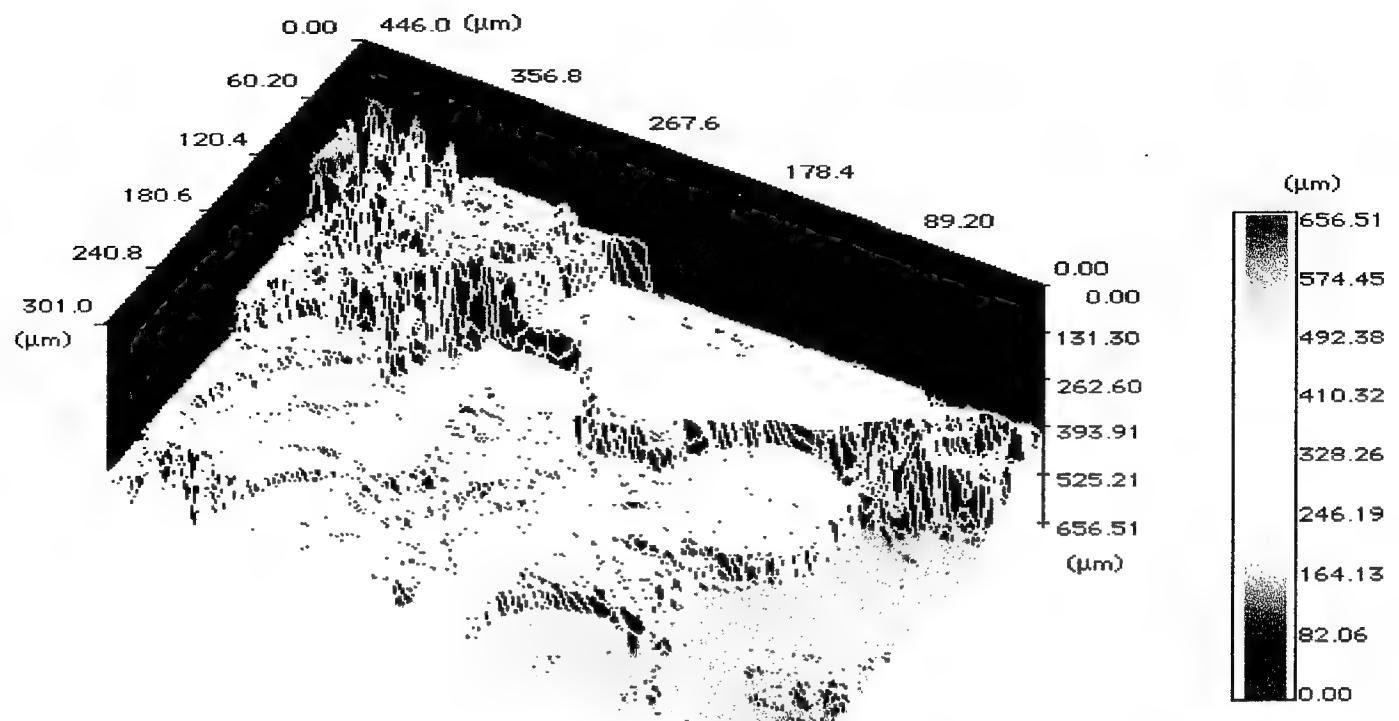
Figure A.3. Contrast and topography images of Surface B.

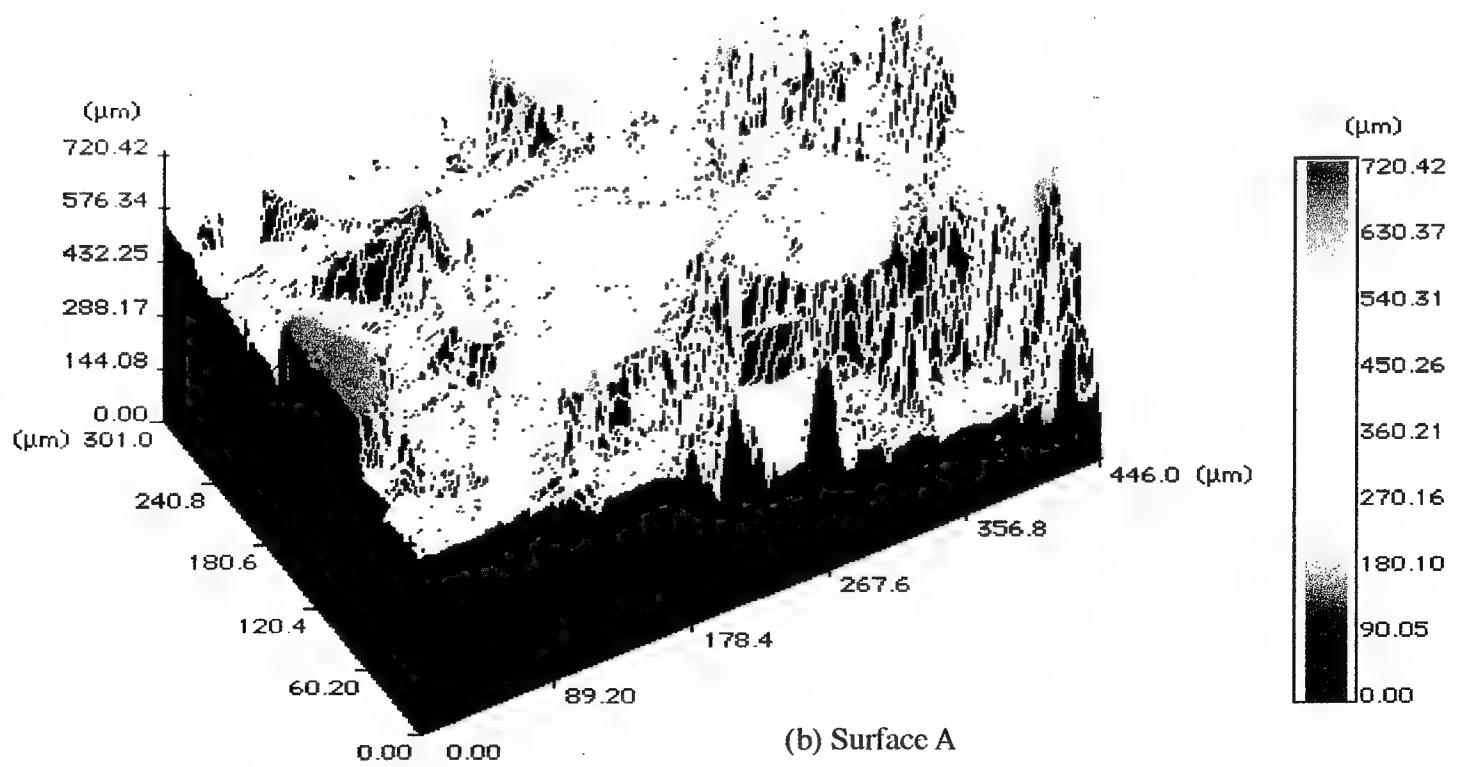
Figure A.4. Perspective views of conjugate fracture surfaces.

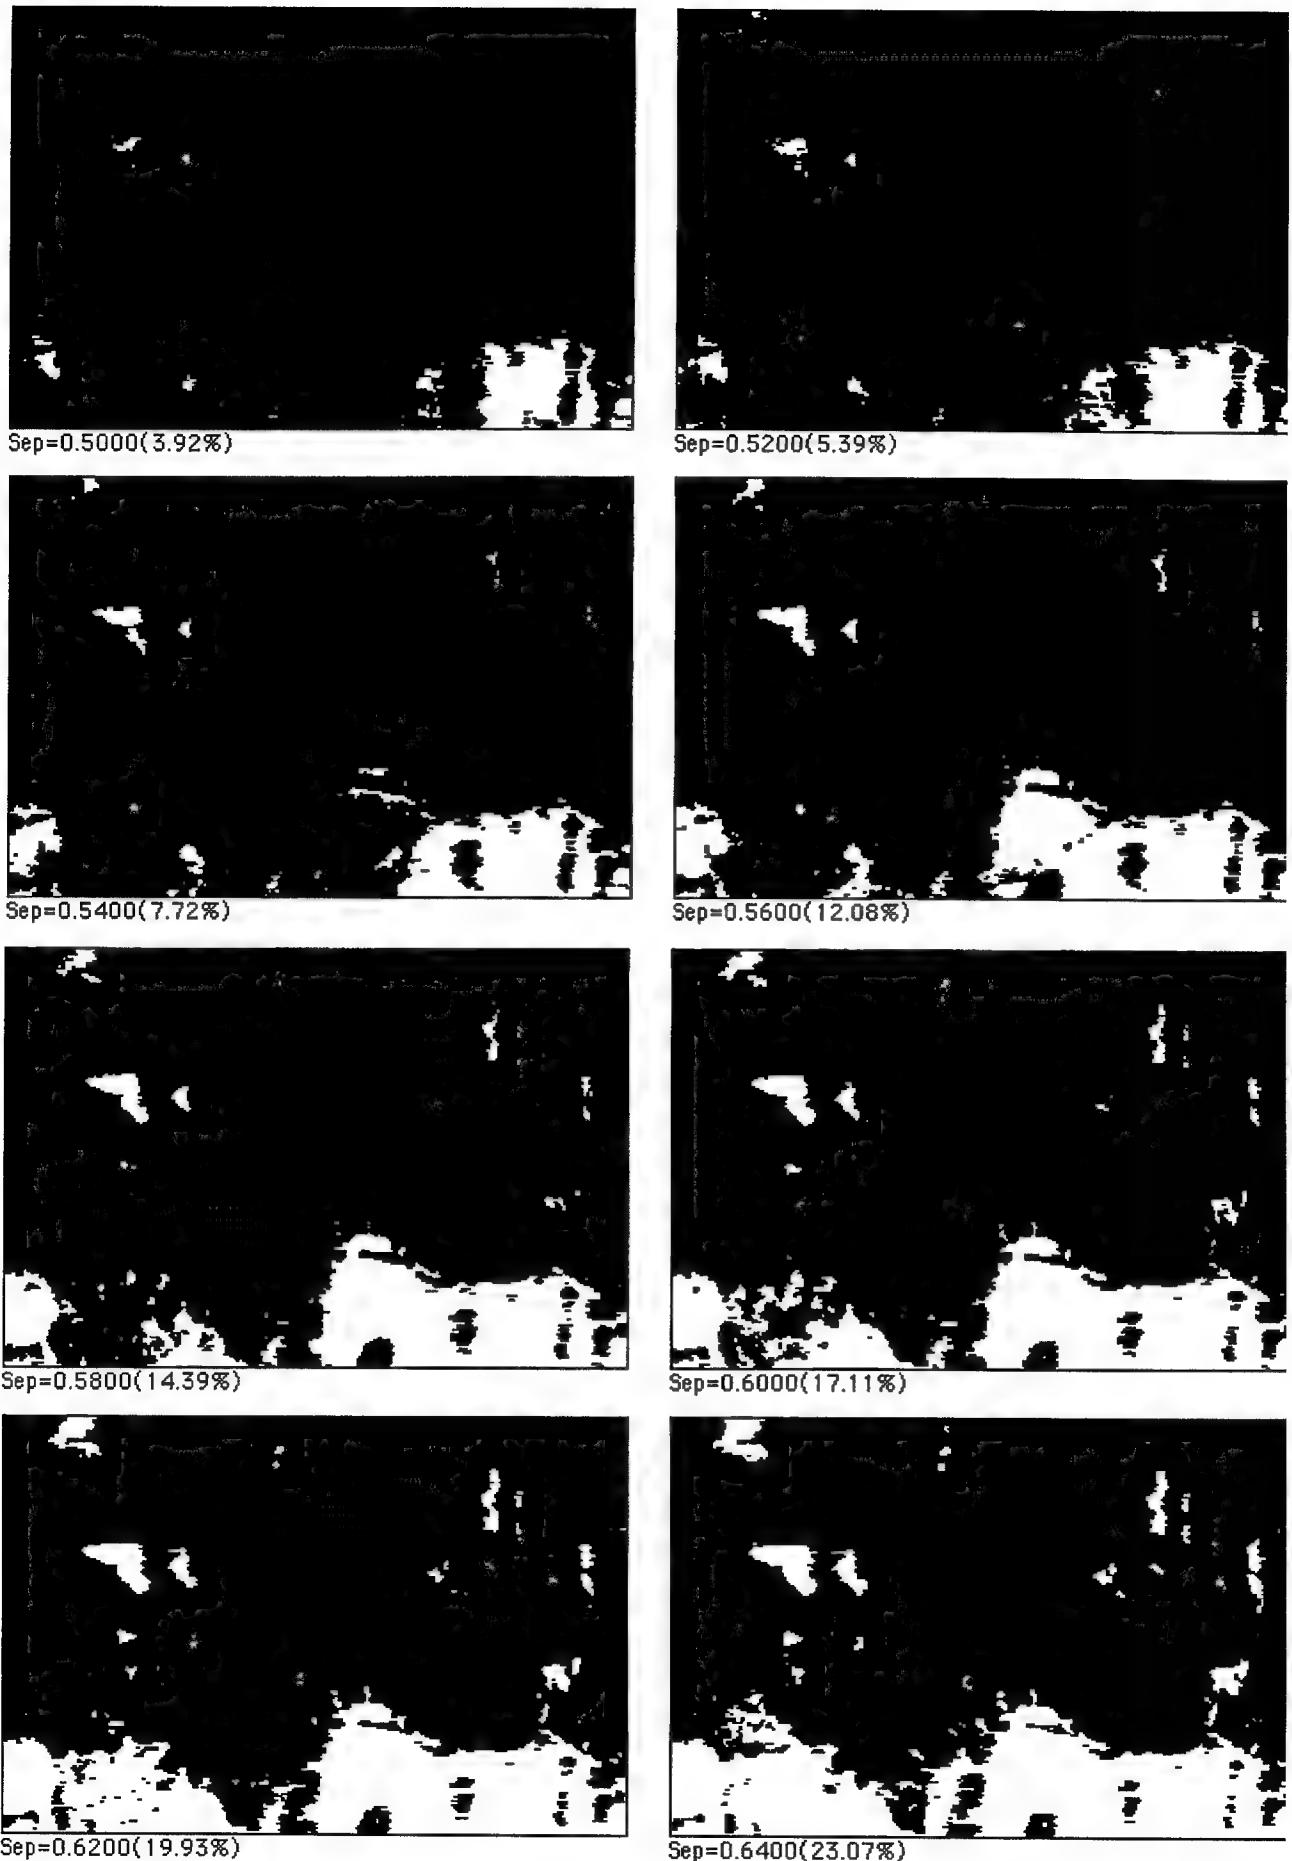
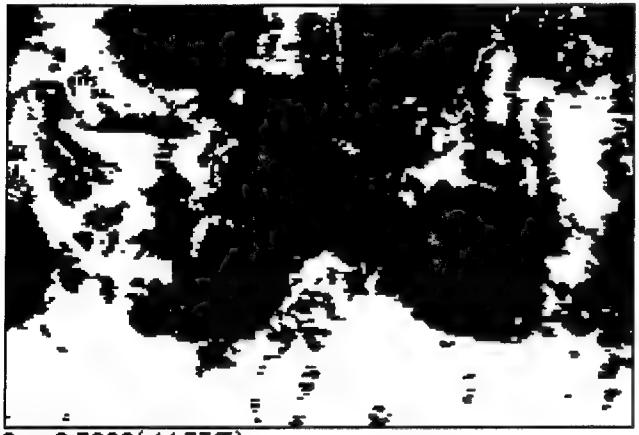
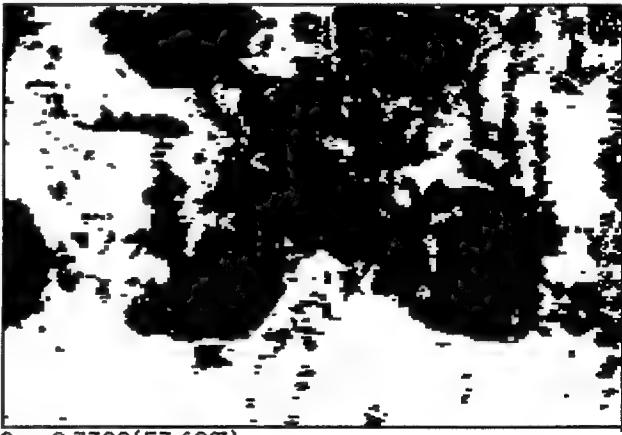
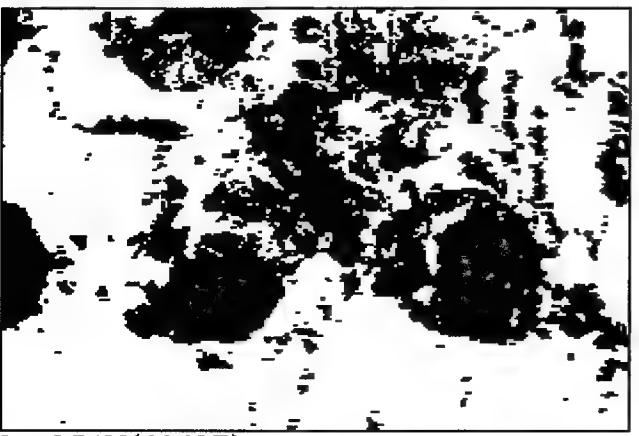
Areas where large gaps exist indicate that material was liberated from the fracture surfaces, probably by fragmentation of the matrix material.

Figure A.5. A series of fractured area projection plots showing microfracture processes inside material.

Figure A.5. A series of fractured area projection plots showing microfracture processes inside material (concluded).
